Concorde Battery Corporation

TECHNICAL BULLETIN

Subject: Thermal Runaway

Number: 2

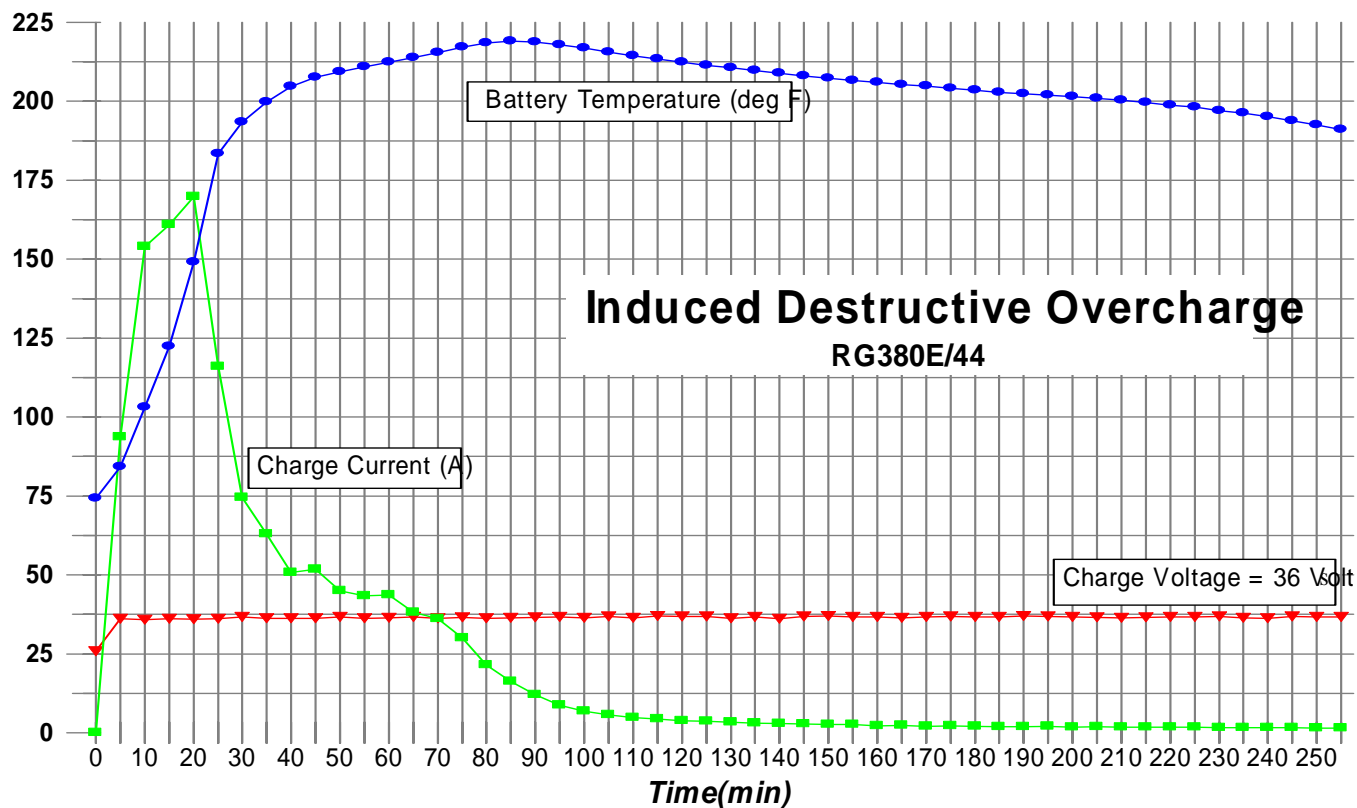
To demonstrate this, the Induced Destructive Overcharge Test in IEC standard 952-1:1988 is conducted. In this test, the battery is intentionally driven into thermal runaway by charging the battery at 3.0 volts/cell and continuing to charge until the battery fails. The battery must contain any flame within the battery both during and after the test, not release any electrolyte from the battery casing, and contain any debris resulting from an explosion either during or after the test. A graph of the typical result is shown on page 2:

The valve regulated lead acid battery in thermal runaway will reach only a relatively moderate internal temperature (approximately 260° F) at which point the water in the electrolyte vaporizes and the battery vents steam. As the separator is glass, it is unaffected by this low temperature. The loss of water caused by the venting reduces the conductivity between the battery plates and the battery ceases to accept further charge. The battery slowly cools.
